NOTE

- The following presentation on "Insights on Identifying Medical Events During Inspections" provides information on causes of medical events and gives some past case examples and the causes of each event.

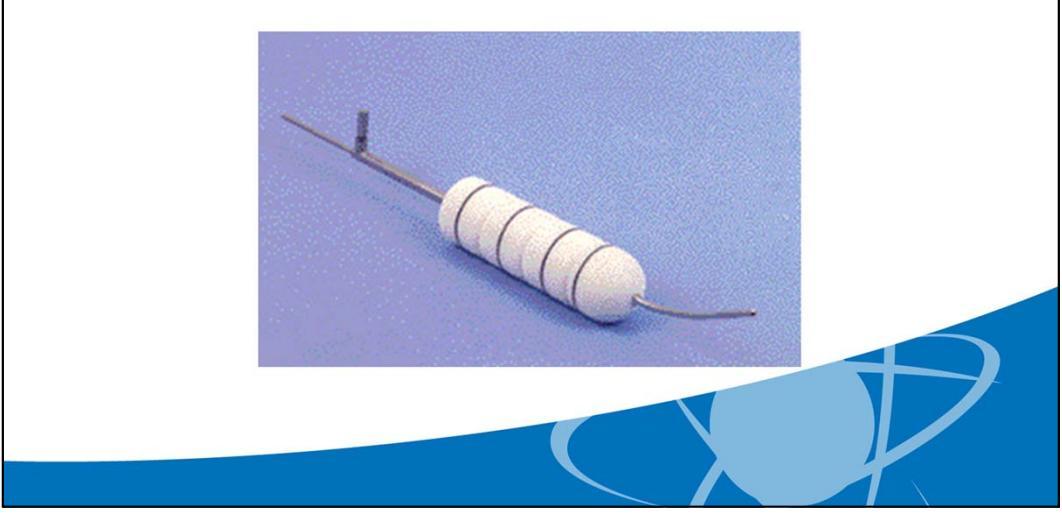
Low Dose Rate Brachytherapy Cs-137 GYN Medical Event

Five GYN cesium-137 brachytherapy treatments resulted in medical events.

Three of the patients developed skin lesions on the upper thighs from radiation doses to the skin of the upper thigh, an unintended treatment site.

The <u>root cause</u> of the medical events was the use of radioactive sources that had a smaller diameter than that specified in the instructions distributed

with the brachytherapy applicator, which allowed the sources to move from their intended position within the applicator (spring) to a position that resulted in the unintended doses to the skin of the patients.

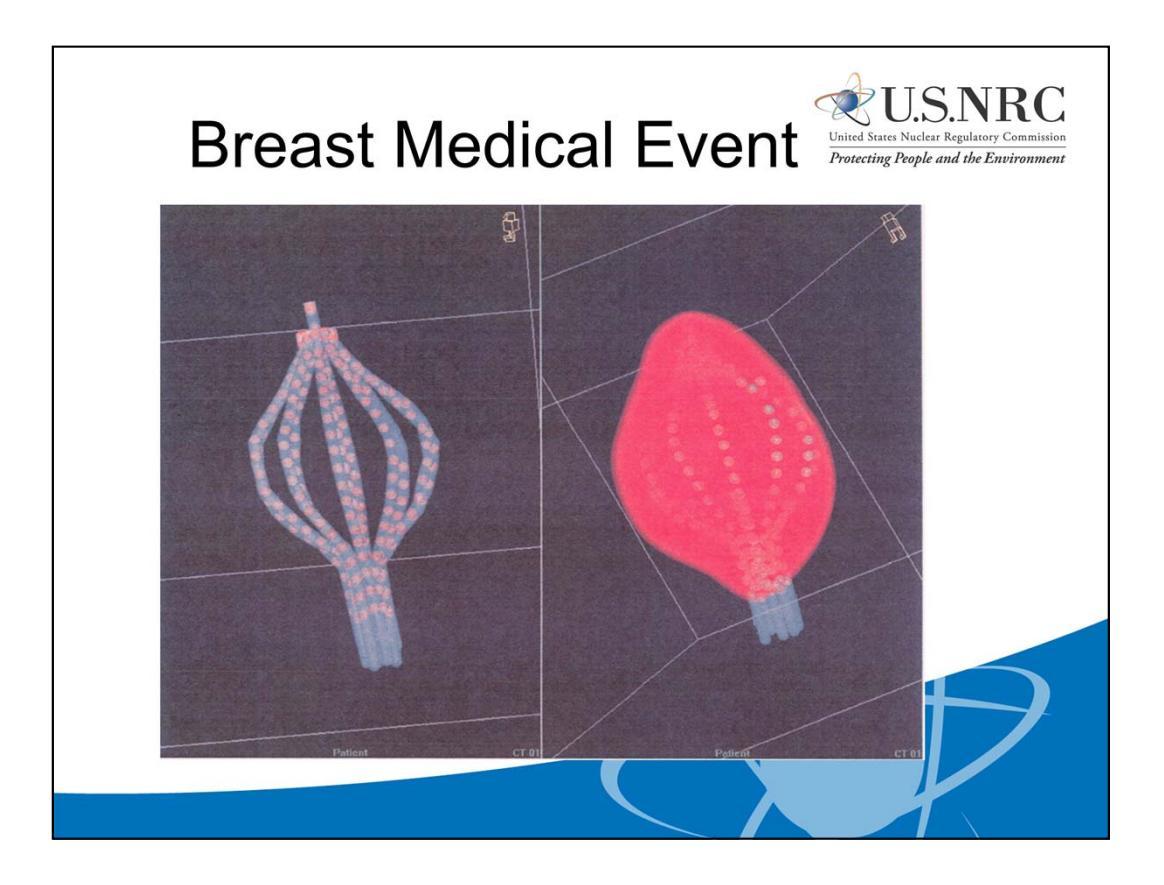
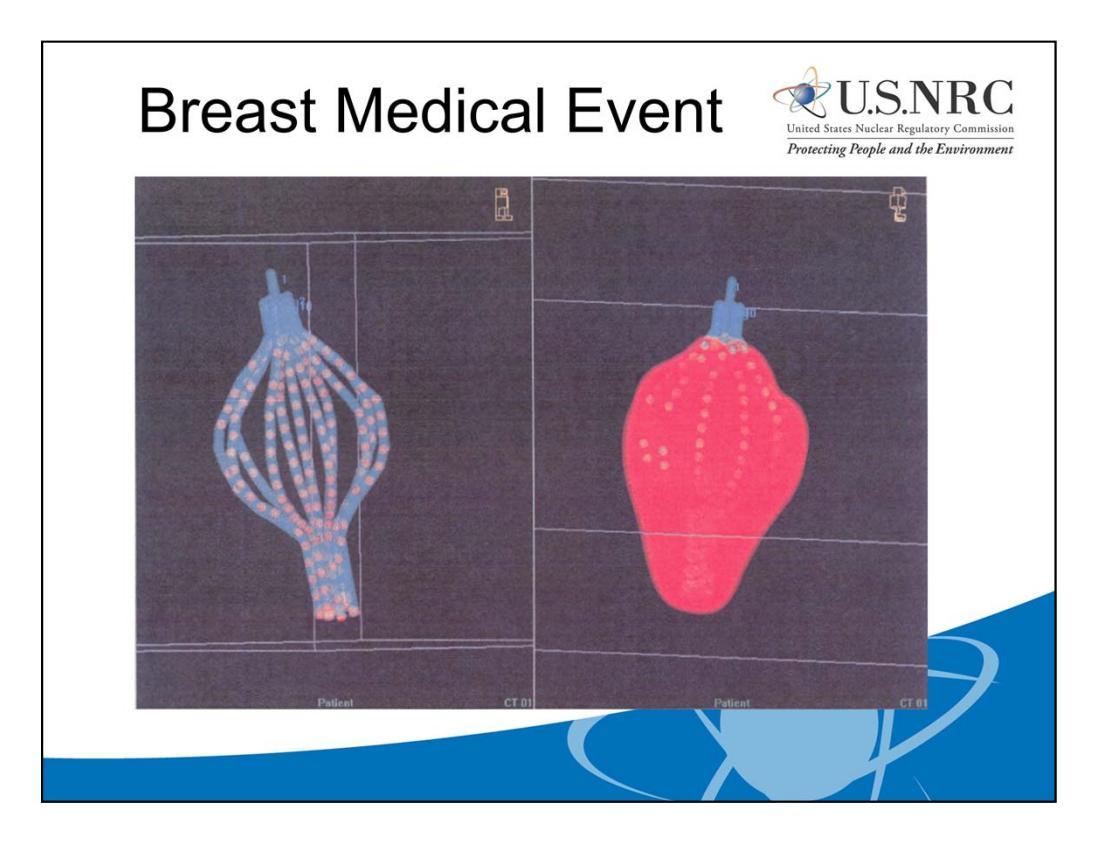
A medical event occurred as a result of mispositioning of the iridium-192 HDR source in the patient's body.

<u>Root Cause:</u> Human error in that the licensee did not accurately reconstruct the applicator in the treatment planning computer for 8 of 10 fractions.

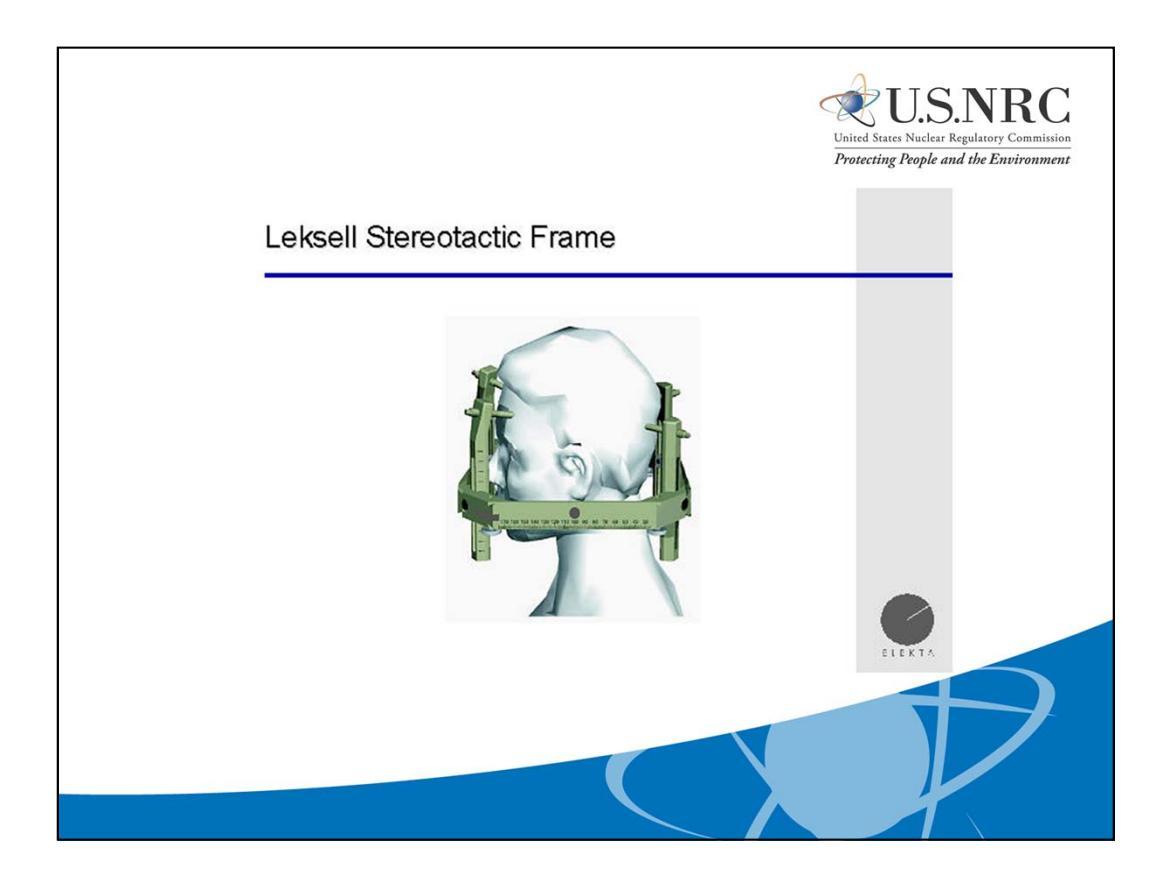
The box positioning error did not effect the X and Y coordinates; however, it resulted in the Z coordinates being inverted. Since the Z coordinates were inverted, the GSR treatment resulted in prescribed doses that were delivered to unintended anatomical areas.

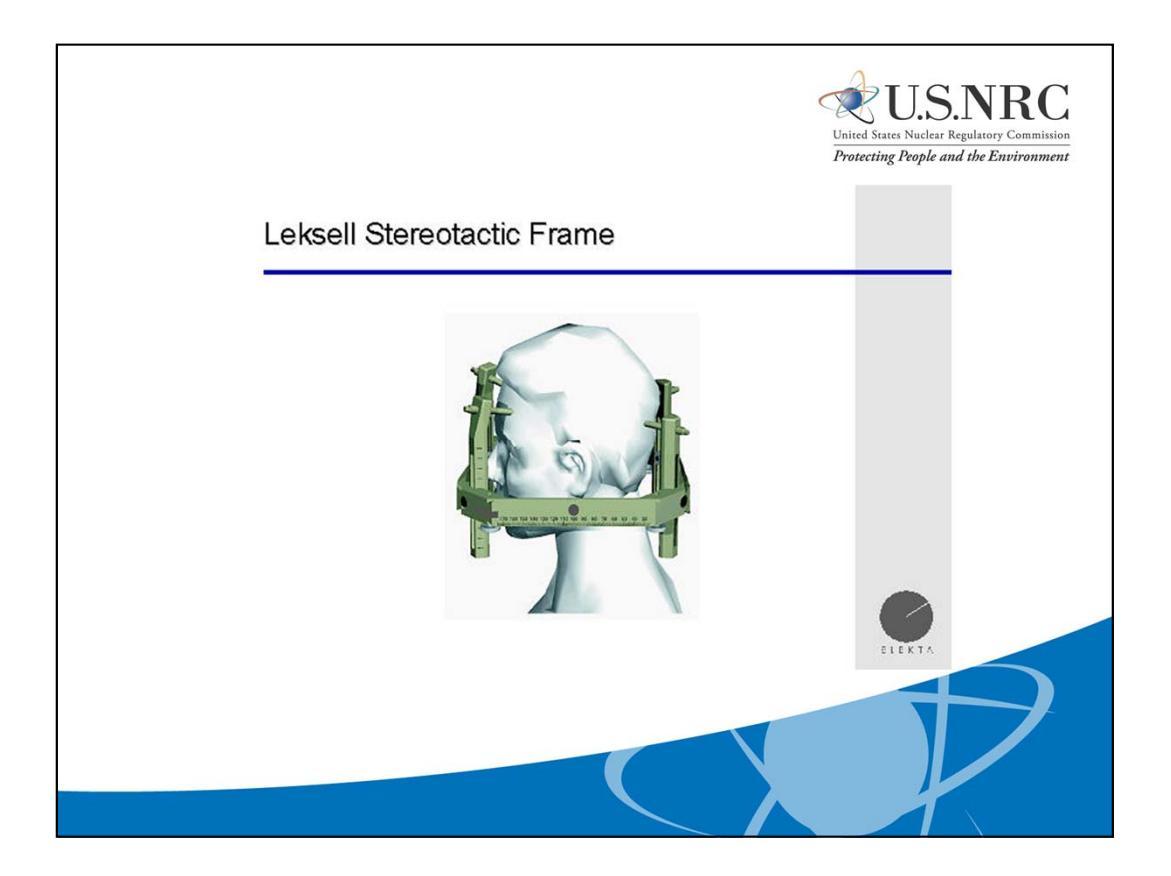
The box was designed with a safety feature to prevent inadvertent wrong positioning of the box onto the frame. Specifically, the box had four pins that, when positioned correctly, would seat into corresponding holes in the frame. One of the pegs was larger than the other three, and one of the holes was larger than the other three. If the box was incorrectly positioned, the larger pin would not seat in the smaller holes, thus preventing the box clamps from latching.

The licensee noted resistance while fastening the box onto the frame. The licensee attributed this resistance to the fact that the box might have been in contact with the top of the patient's head which, in turn, would not let it lower to the point where the box clamps could fasten onto the frame. However, the resistance was due to the fact that the box had been positioned incorrectly.

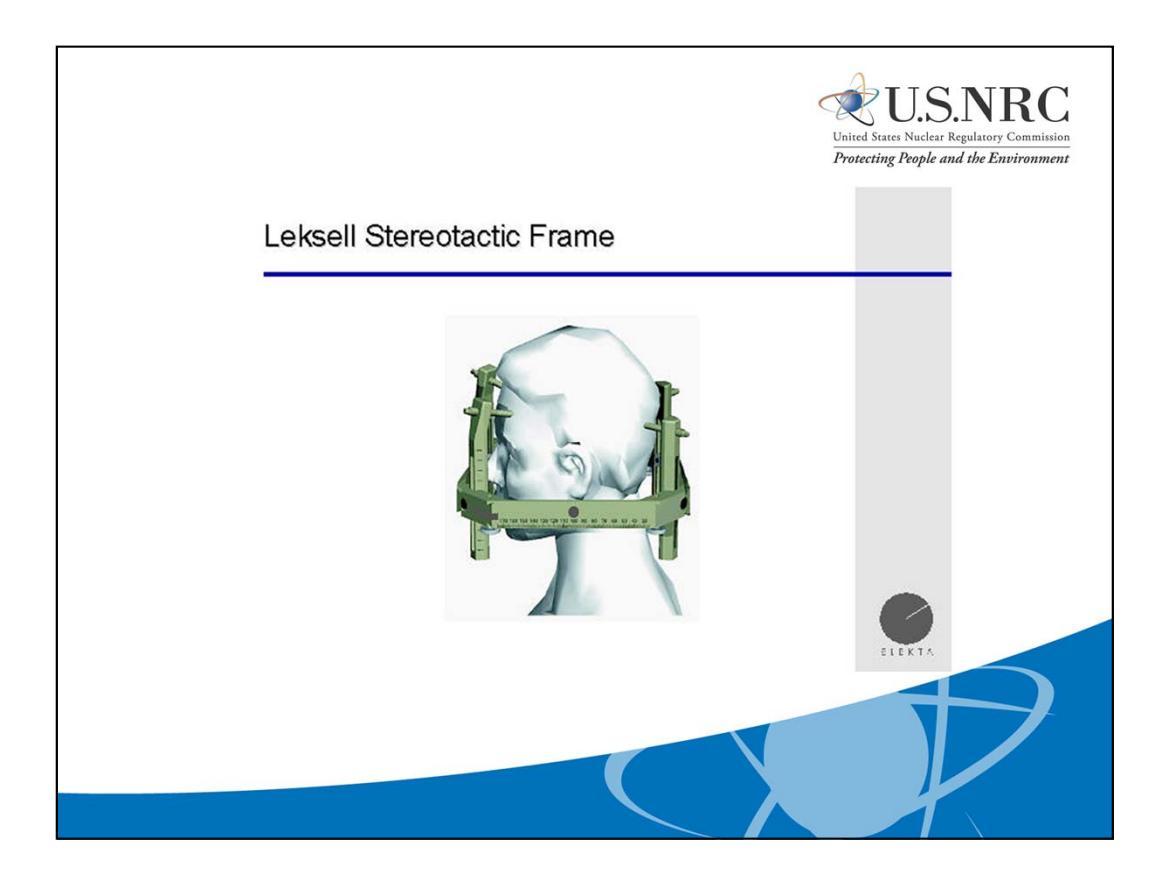
The resistance was actually the result of the large box pin not seating in one of the frame's smaller holes due to the erroneous box position. The licensee applied sufficient force to clamp the box to the frame even though the large pin had not seated in the smaller hole.

The safety feature, intended to prevent incorrect attachment of the box to the frame, failed because the unseated, large pin was too short, and this allowed the plastic clamps to flex enough to latch to the frame. After attachment, the licensee didn't notice that the large pin on the box was not seated in the smaller hole in the frame. Authorized staff were aware of the safety feature and assumed that there was no way the box could be attached to the frame incorrectly.

Failure of the safety feature was a contributing factor to the event.
