NOTE

- The following presentation on "Insights on Identifying Medical Events During Inspections" provides information on causes of medical events and gives some past case examples and the causes of each event.

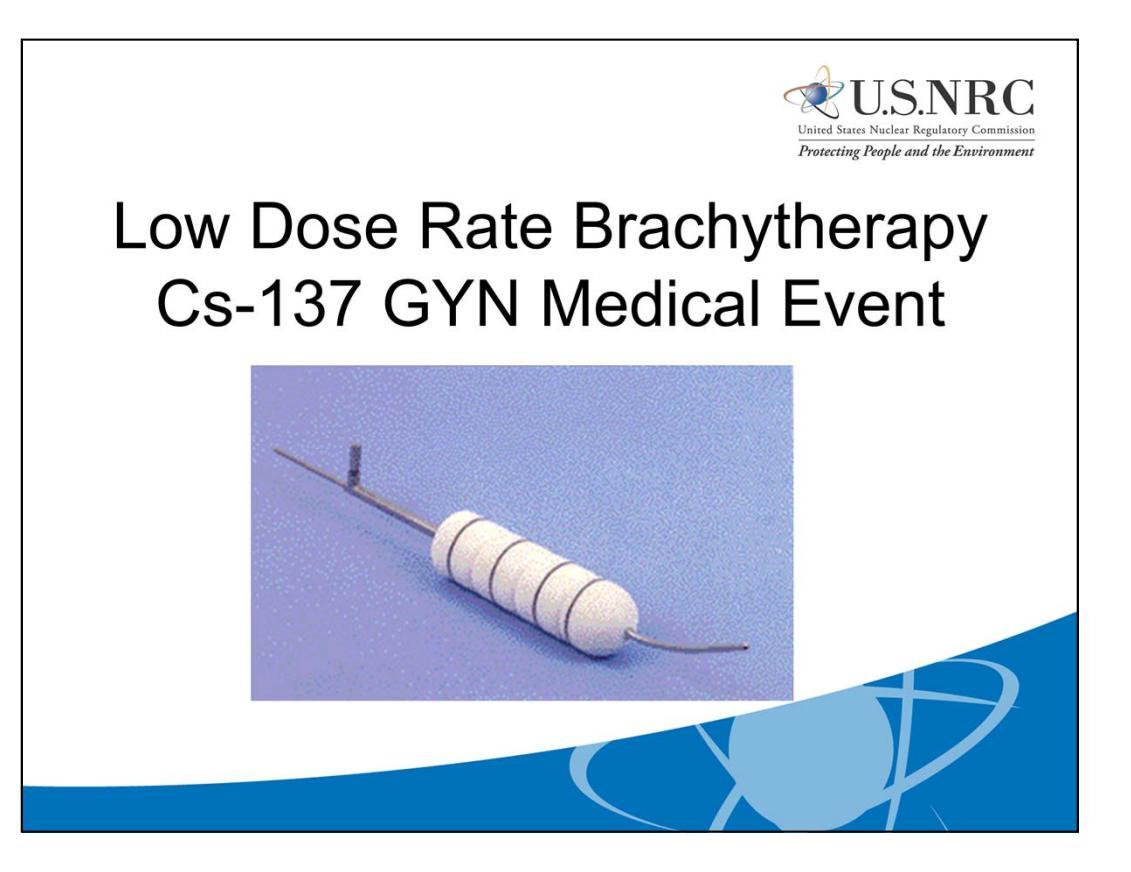
Case 1:

During an inspection to review two medical events that were reported, the inspector identified three additional patients that had similar treatments as those that resulted in the reported medical events, and one of those additional patients exhibited observable side effects.

Five GYN cesium-137 brachytherapy treatments resulted in medical events.

Three of the patients developed skin lesions on the upper thighs from radiation doses to the skin of the upper thigh, an unintended treatment site.

The <u>root cause</u> of the medical events was the use of radioactive sources that had a smaller diameter than that specified in the instructions distributed

with the brachytherapy applicator, which allowed the sources to move from their intended position within the applicator (spring) to a position that resulted in the unintended doses to the skin of the patients.

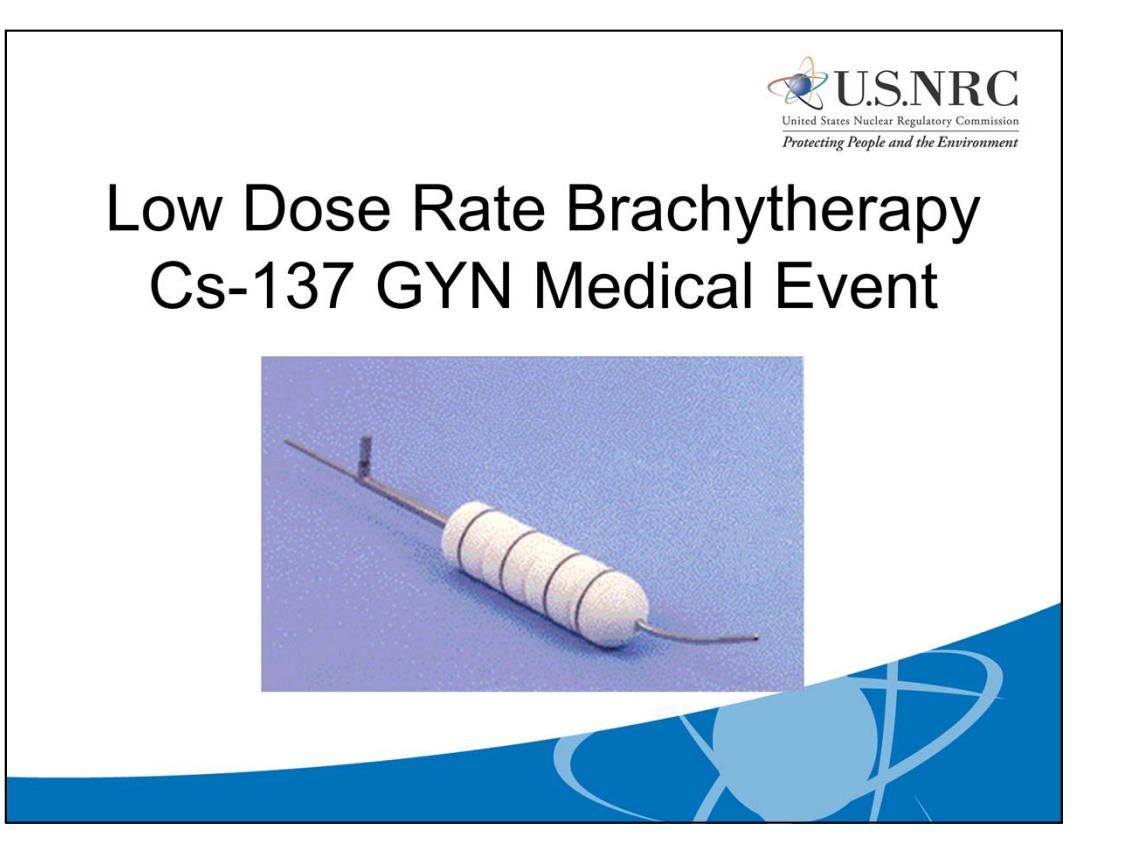
Contributing causes were:

1. The instructions provided by the manufacturer of the applicator were inadequate because the instructions did not provide adequate caution statements regarding the physical dimension requirements of sources to be used in the applicator.

Specifically, the instructions did not provide sufficient specificity regarding the physical dimension requirements of the sources to be used; and

The instructions permitted the use of other manufacturers' sources, but did not provide cautions regarding the use of sources that were of a smaller diameter than those from the specified source manufacturer.

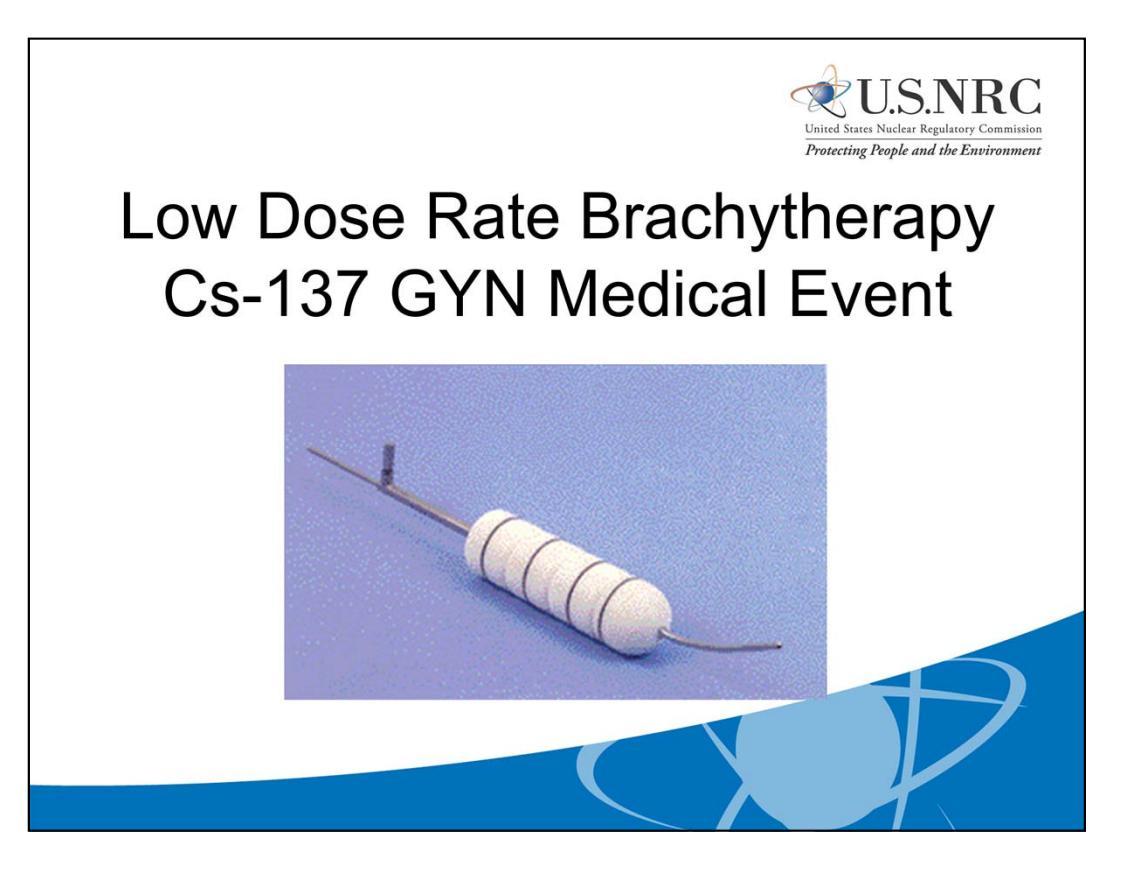
2. The licensee provided poor supervision of contract medical physicists.

Specifically, the licensee relied on contract medical physicists to self-instruct and familiarize themselves with the applicator prior to its use.

A contract medical physicist involved in the five brachytherapy treatments was not familiar with the use of the particular applicator and did not recognize that the two sets of brachytherapy sources possessed by the licensee were physically different in a critical dimension; and

Neither the licensee nor the authorized user provided specific instructions to the contract medical physicists regarding technical limitations associated with the use of the applicator.

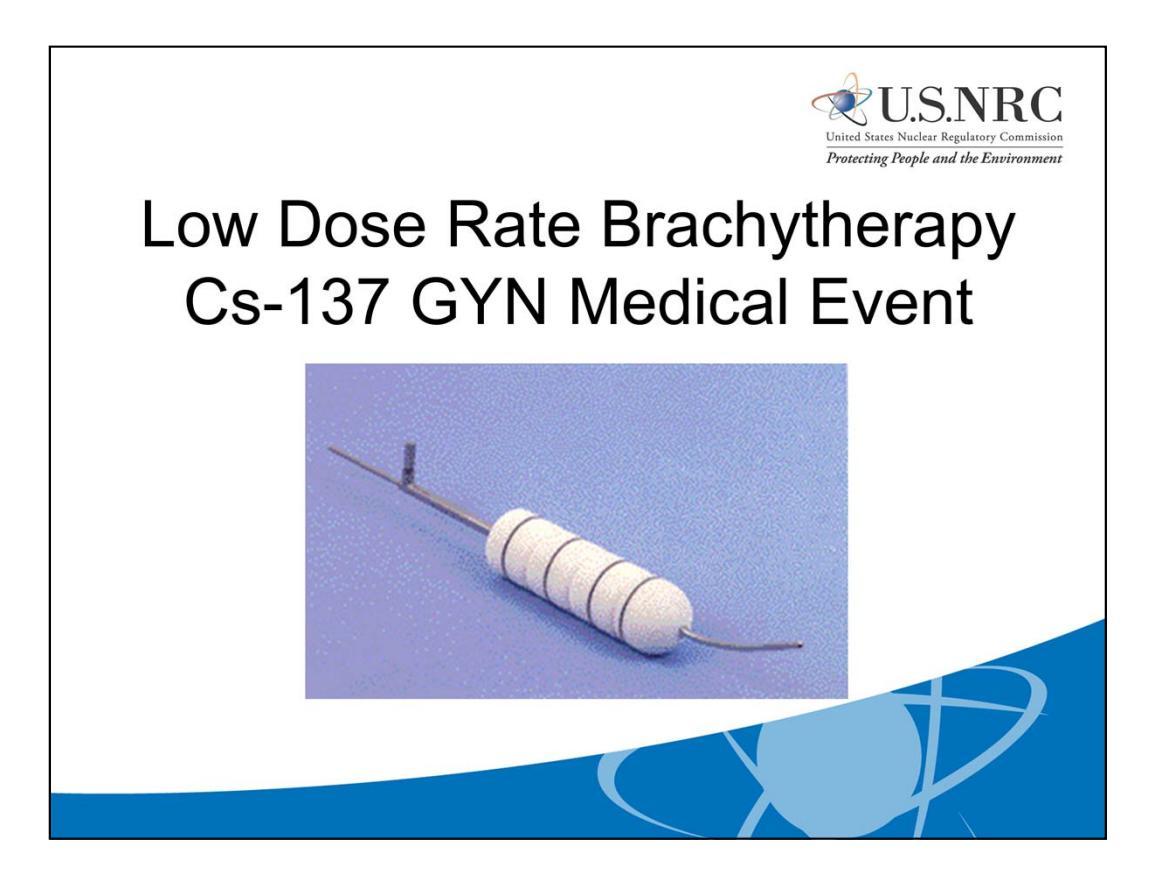
3. Licensee staff failed to read the instructions provided with the applicator and therefore, did not follow the instructions.

The instructions specified the use of sources manufactured by 3M and the applicator was marked with the appropriate source dimensions; however, during each of the 5 medical events, the contract medical physicist selected G.E. Healthcare sources for use in the applicator because he assumed that all of the sources were manufactured by 3M and did not recognize that he had selected sources from a different manufacturer.

The physicist did not recognize that the difference in source dimensions could impact their use in the applicator. Therefore, since he failed to thoroughly read the instructions and failed to recognize that the licensee possessed two sets of sources that were different in a critical dimension, he used G.E. Healthcare sources in the applicator that were too small in diameter.

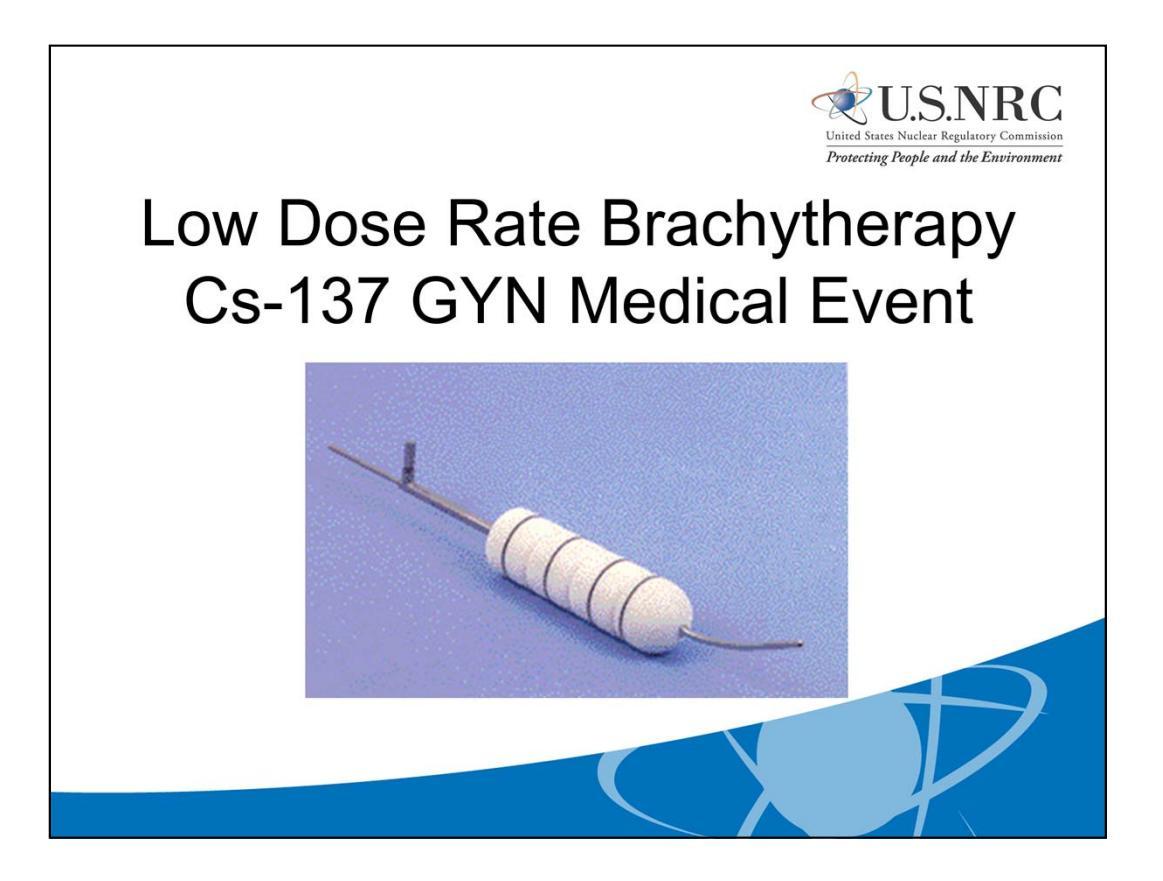
4. The licensee's procedures for manual, low-dose-rate brachytherapy administrations were inadequate.

Specifically, the licensee 's procedures did not require verification that the sources used with the applicator were appropriate to administer the treatment as prescribed on the written directive; and

The licensee's procedures referenced obsolete requirements that existed prior to the April 2002 revision of 10 CFR Part 35.

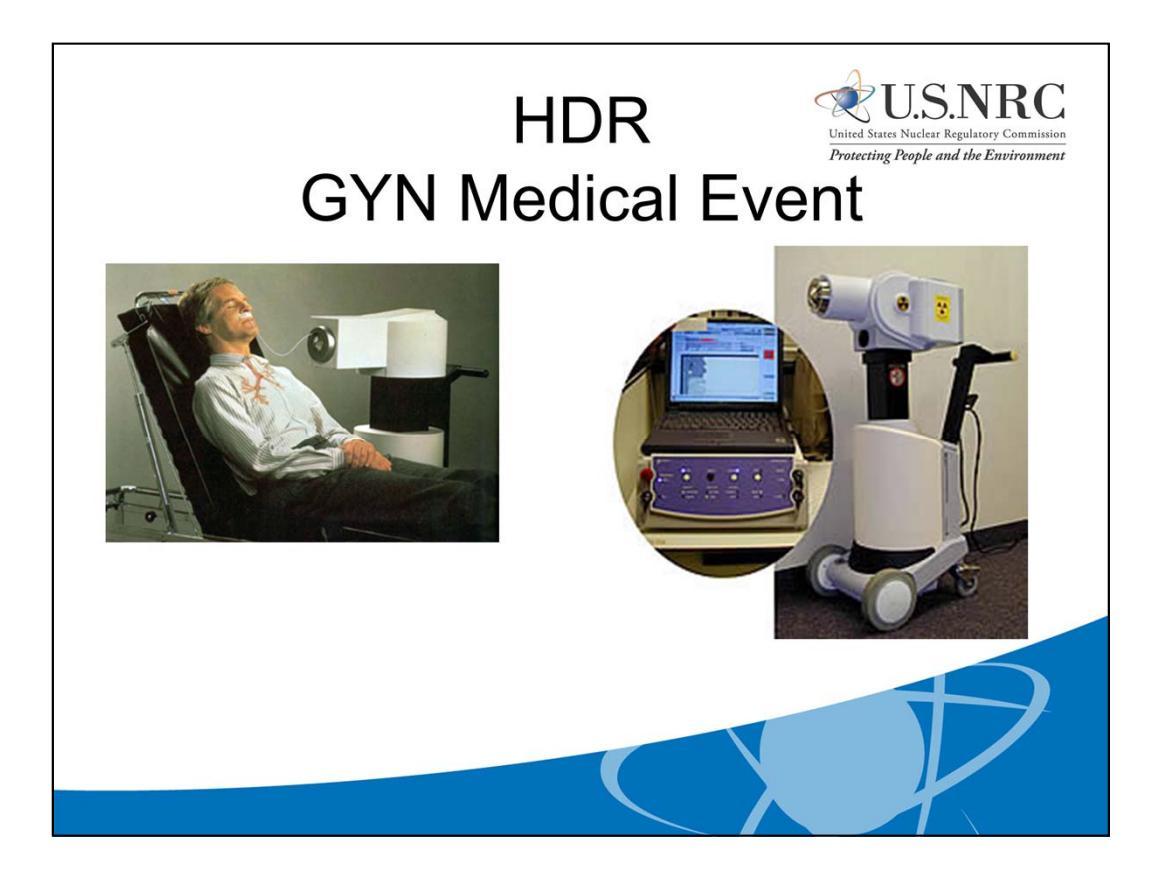
An inspector identified an HDR medical event that occurred during the licensee's administration of three treatment fractions administered to a patient.

An NRC Medical Consultant concluded that the medical event resulted in: (1) an overdose to the vaginal vault that is unlikely to cause vaginal necrosis; and (2) an under dosage to the inferior-posterior vaginal wall (which contained cancer) that increases the risk of cancer recurrence.

While reviewing selected HDR treatment records with a medical physicist, including written directives, treatment plans, pre-treatment HDR device settings, and post-treatment HDR device settings, the inspector noted that one of the treatments had an error involving entering the wrong step size into the HDR unit that was used for the treatment.

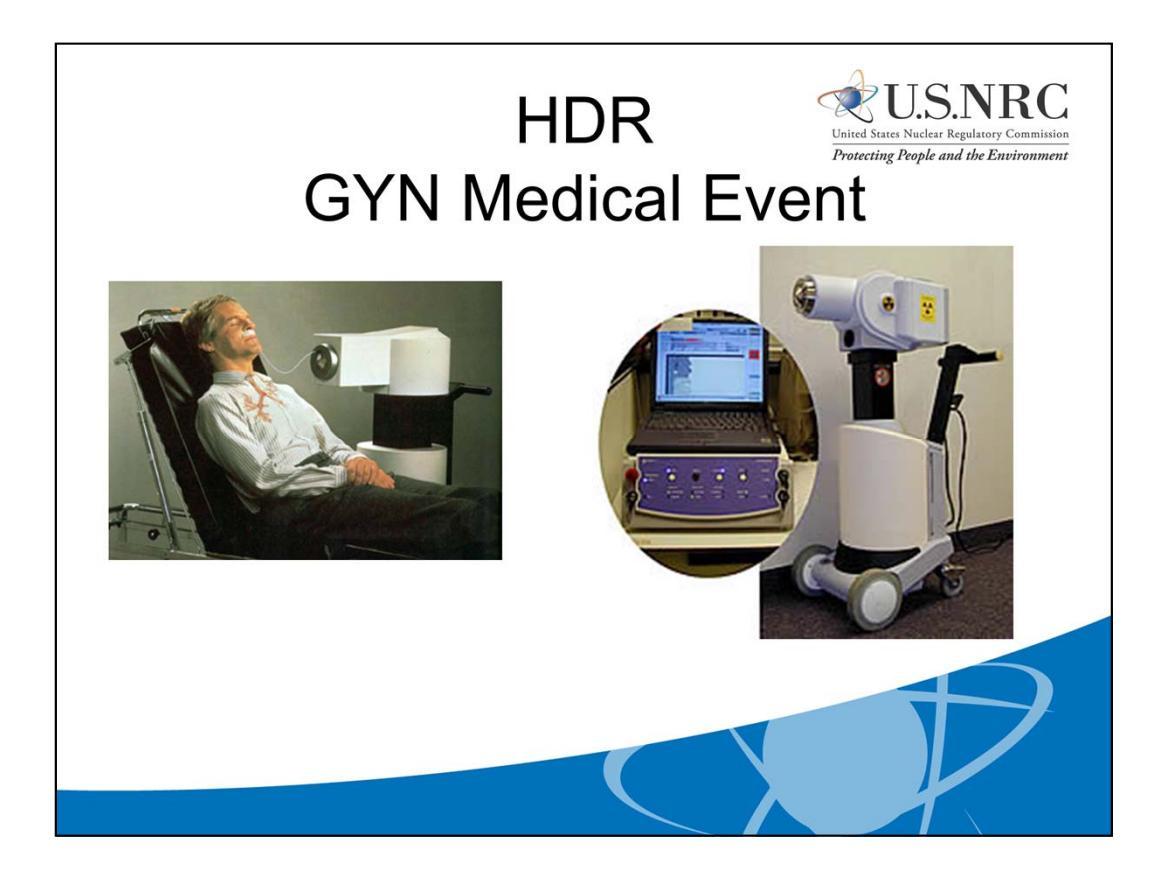
Root Cause: Error in entering the step size into the HDR unit.

Contributing Causes:

- (1) licensee failure to instruct an Authorized Medical Physicist (AMP) on written directive (WD) procedures;
- (2) AMP's failure to read the licensee's WD procedures until the inspection;
- (3) inability to transfer the treatment data electronically to the HDR unit for the treatment;
- (4) the AMP's perceived sense of urgency to complete the treatment because of the patient's discomfort;
- (5) the licensee staff's failure to check that the step size data was properly transferred to the HDR unit prior to the treatment; and
- (6) Use of an HDR unit's default step size setting of 2.5 millimeters when 5 millimeters was normally used by the licensee (BIG VULNERABILITY!)

The licensee lost an opportunity to identify the medical event because a staff member failed to check that the step size that was actually used for the treatment was in agreement with the treatment plan after administration of the treatment.

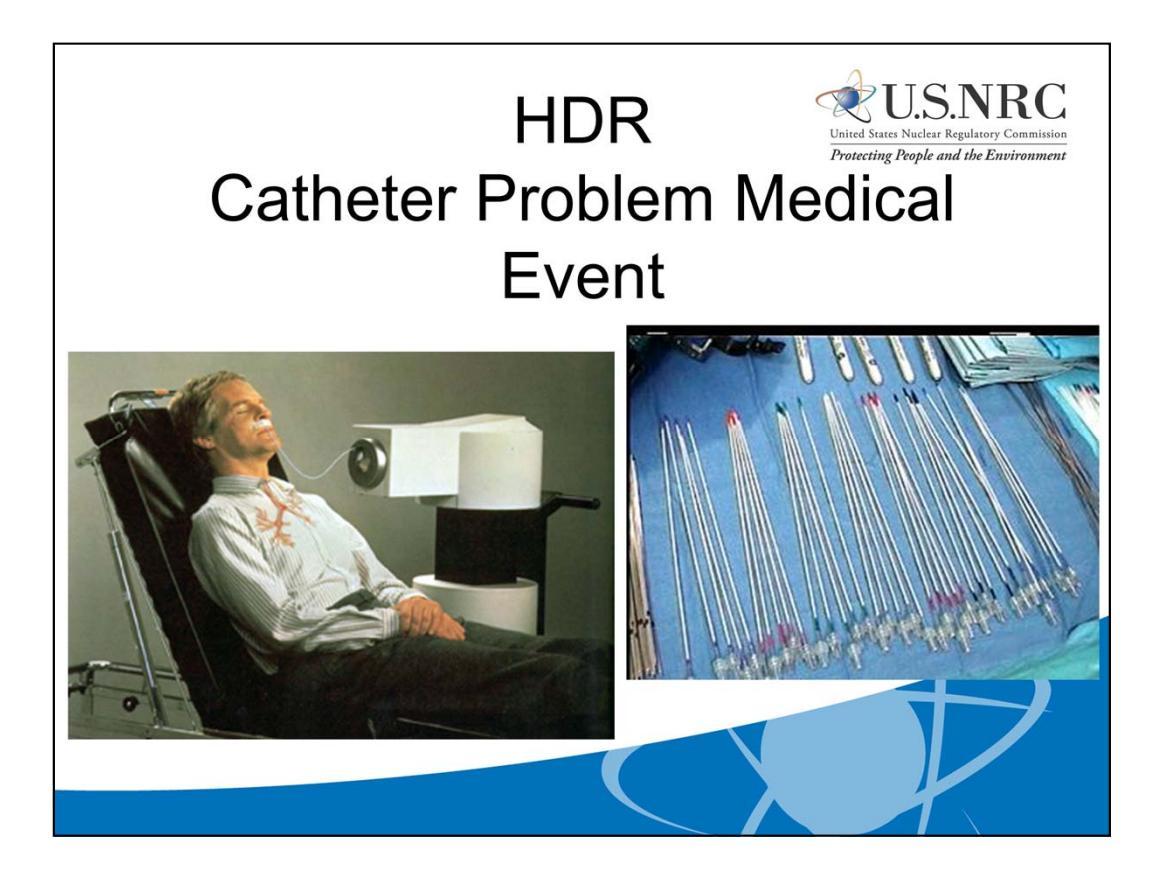
Case 5:

A medical event under dose occurred.***

<u>Cause:</u> The patient's treatment catheters were incorrectly connected to the HDR unit. Specifically, the patient's treatment catheters were connected to onemeter long transfer tubes that were connected to the HDR unit, instead of being directly connected to the HDR unit per the manufacturer's instructions.

As a result, the treatment site did not receive any dose during the treatment because the radioactive source remained outside the body and delivered an estimated dose of 1.8 rad to the patient's skin on the patient's left shoulder and upper arm.

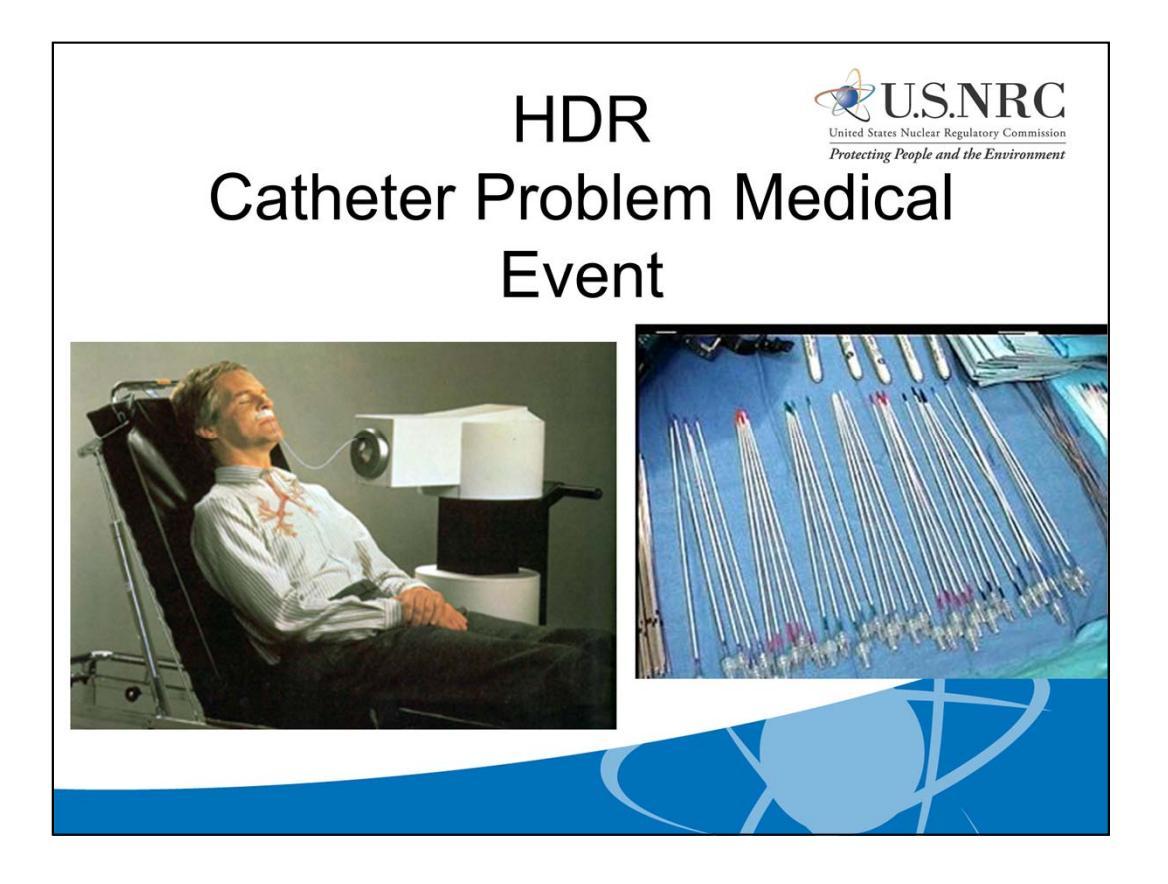
<u>Root Cause:</u> The licensee's written procedures failed to ensure that the patient's treatment catheters were appropriately connected to the HDR unit such that the administration would occur in accordance with the written directive. A violation was identified involving licensee failure to develop written procedures to provide high confidence that each administration is in accordance with the written directive (10 CFR 35.41).

Corrective Actions:

The licensee:

- (1) revised its written procedures to require the physicist and an independent staff member to review and verify the correctness of the connections to the HDR unit (dual independent verification)
- (2) provided training to all affected users on the revision to the written procedure;

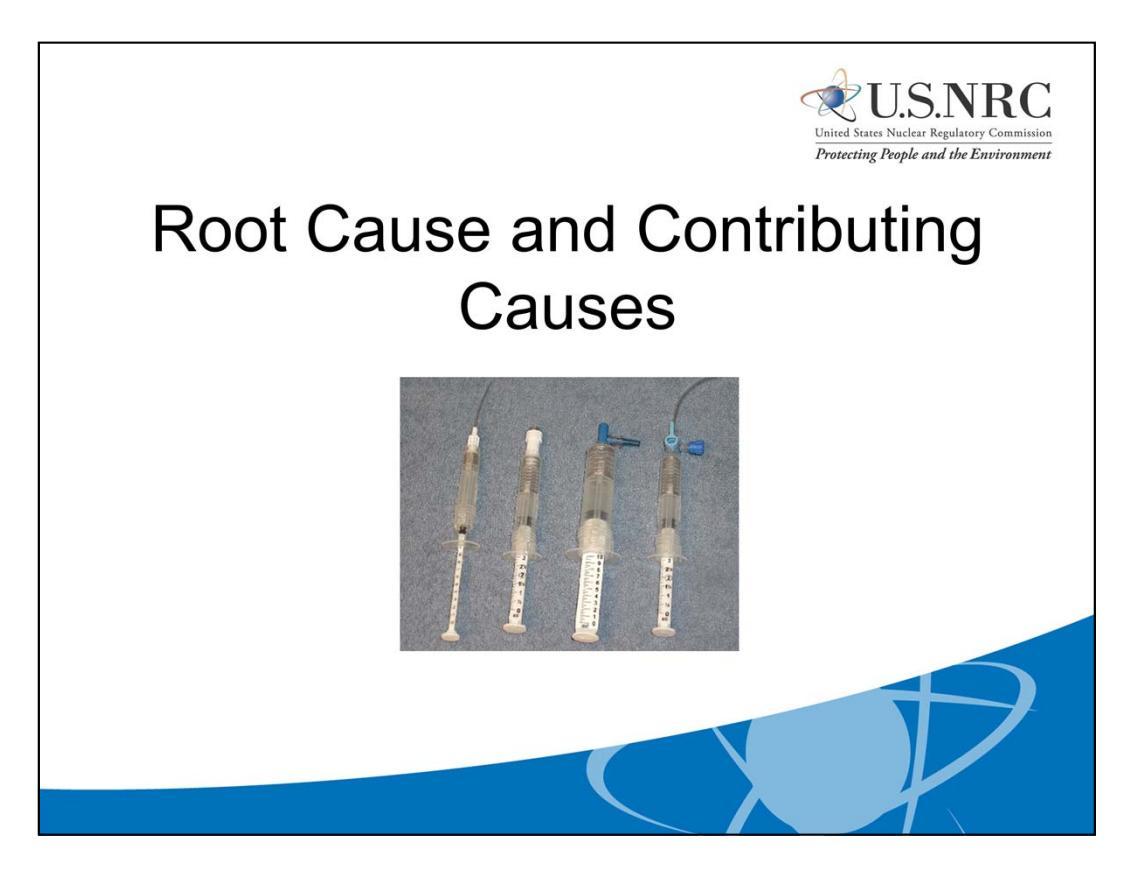
The root cause of the medical event was that the syringe containing the dosage started to slip out of the syringe shield during an attempt to connect the shielded syringe to the intravenous connector, resulting in inadvertent dosage loss when the Authorized User attempted to stop the syringe from slipping completely out of the syringe shield.

Contributing causes to the medical event included:

- (1) the dosage's high specific activity (larger loss of activity per unit volume lost);
- (2) the licensee's removal of the needle from the syringe without first pulling the material out of the needle and into the syringe (lost activity contained in the needle);

(4) The inability of the syringe shield to secure the syringe within it;

(5) the Authorized User's lack of training on how to prevent the syringe from disengaging from the syringe shield;
